DAM SAFETY INSPECTION REPORT

ECHO LAKE DAM

FILE NUMBER: 0142-002

INSPECTED: NOVEMBER 26, 2024

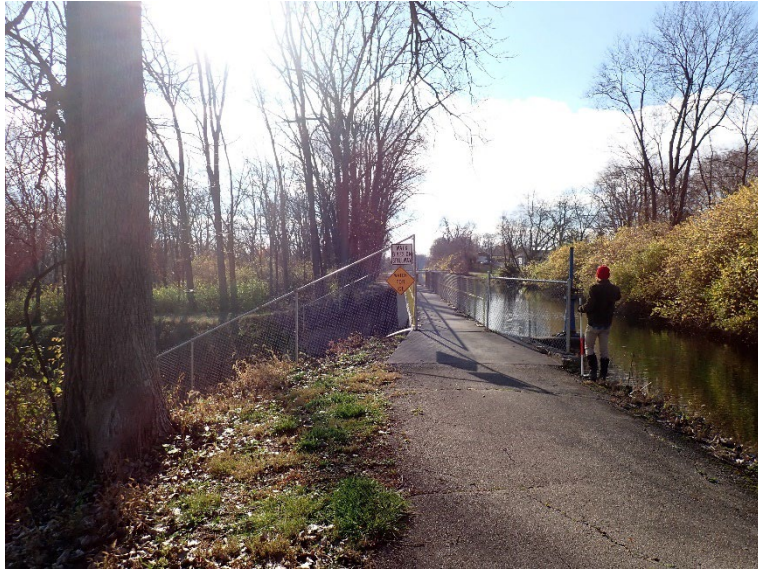
1. Canal path leading from Swift Run Lake Dam to principal spillway #1.

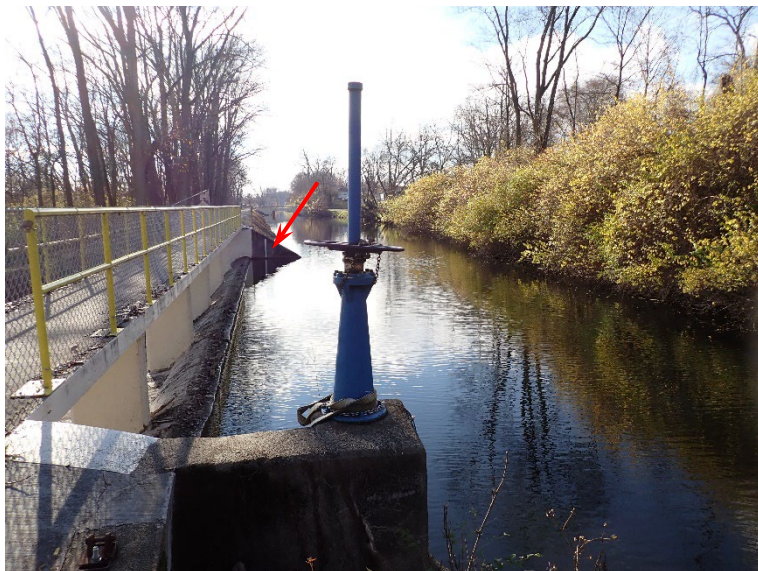
2. Principal spillway #1 inlet. Note the lake drain valve at the left end and the staff gauge at the right end.

FRANZ POND AND ECHO LAKE DISCHARGE ALONG CANAL TO SPILLWAY #1. THE LAKE DRAIN AT SPILLWAY #1 IS OPERABLE BUT ITS UNCLEAR HOW QUICKLY BOTH LAKES AND THE CANAL CAN BE DRAWN DOWN.

3. This dam must have a device to permit draining of the reservoir within a reasonable period of time in accordance with OAC Rule 1501:21-13-06. Investigate the integrity of the lake drain pipe and valve and determine whether the current lake drain structure can adequately lower the pool level in a timely manner for an emergency condition. If necessary, prepare plans and specifications for the installation of such a device. See the "Lake Drains" fact sheet for additional information.

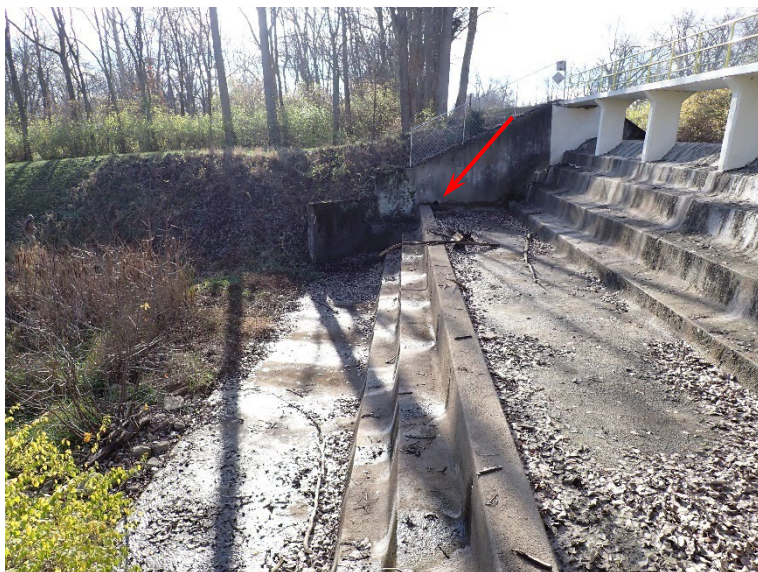
3. Principal spillway #1 outlet. Note the pipe opening (of unknown purpose) in the right sidewall.

SPILLWAY CONCRETE APPEARS TO BE OK WITH A STAFF GAGE ON RIGHT WALL. UNKNOWN SANDPIPE AND OPENING AT BASE OF SPILLWAY WALL SHOULD BE INV.

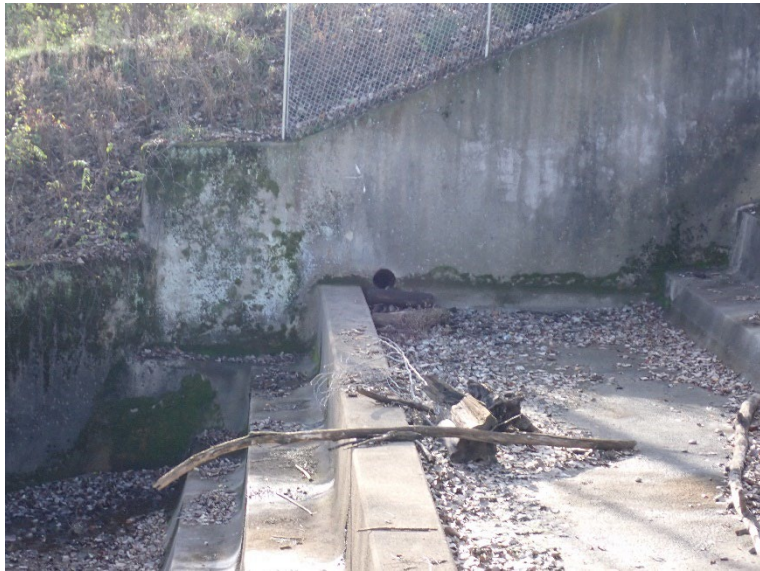
4. Closer view of the pipe opening in the right sidewall.

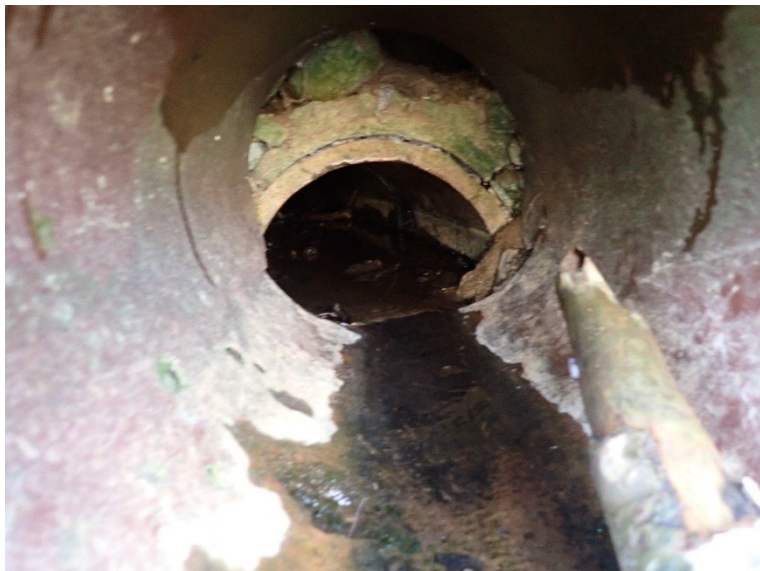
5. Interior view of the pipe opening in the right sidewall. Note the open joint and pipe displacement.

OUTLET APPEARS TO HAVE SETTLED AND MUST BE REPLACED.

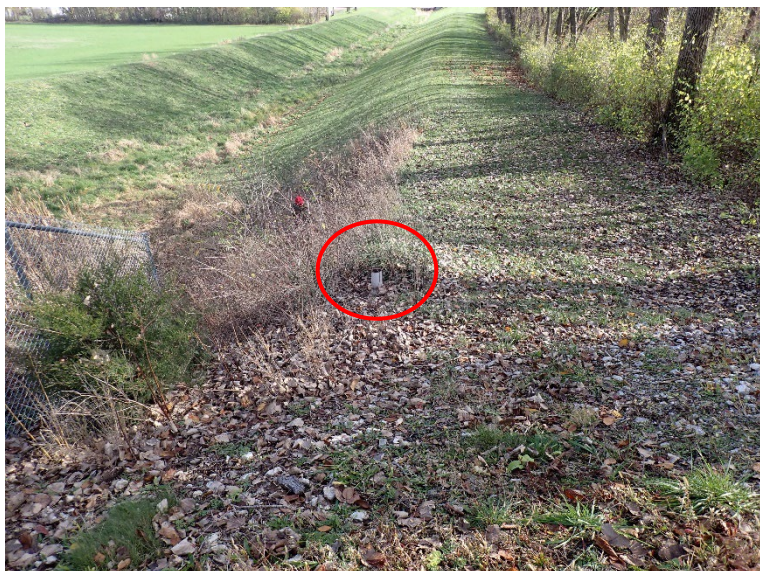
6. There is a standpipe of unknown purpose adjacent to the unknown piping through the sidewall.

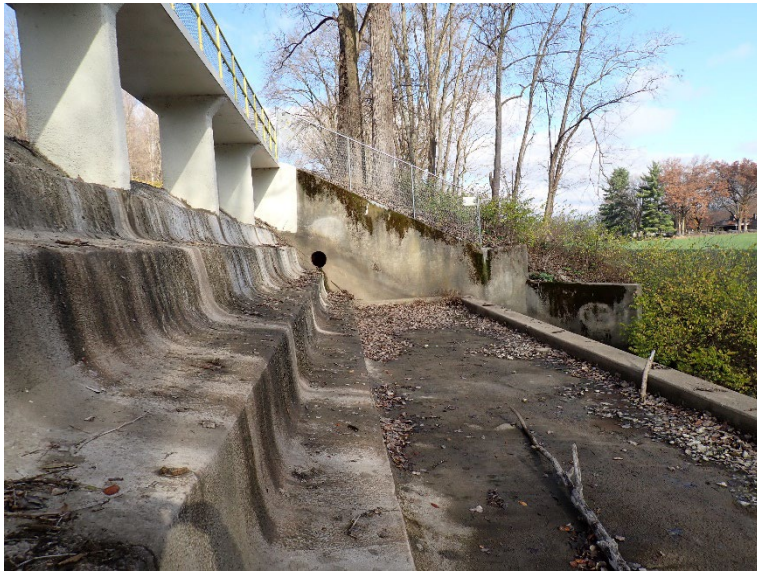
7. View of the principal spillway outlet facing the left sidewall. The opening in the wall is the lake drain outlet.

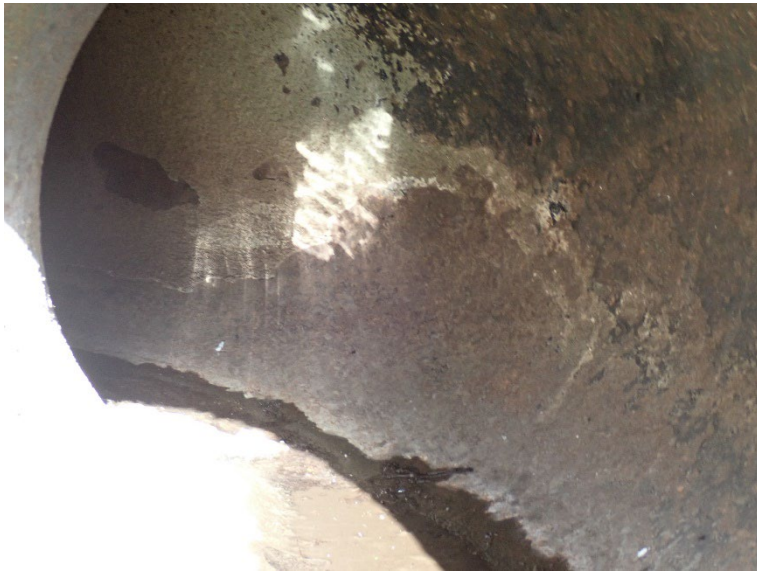
8. Interior view of the lake drain outlet pipe.

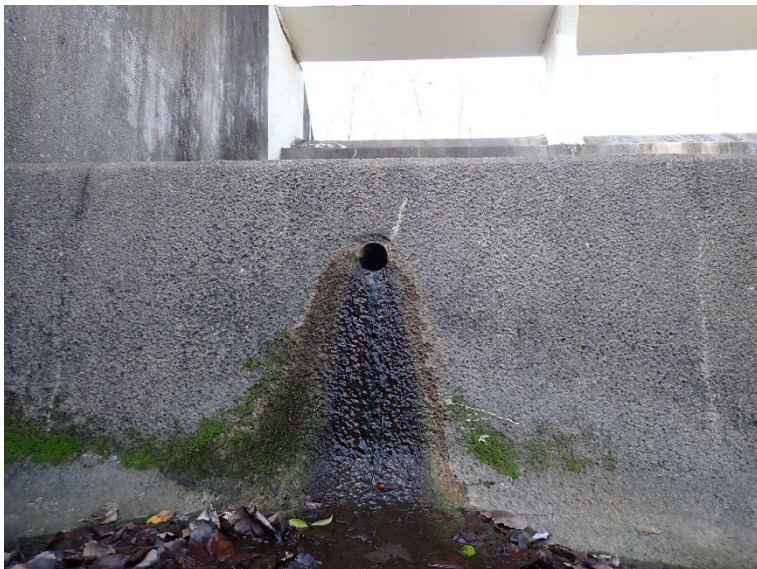
9. The face of the steps in the bottom of the spillway outlet had several relief drains. All drains had a trickle flow or were damp from previous flow.

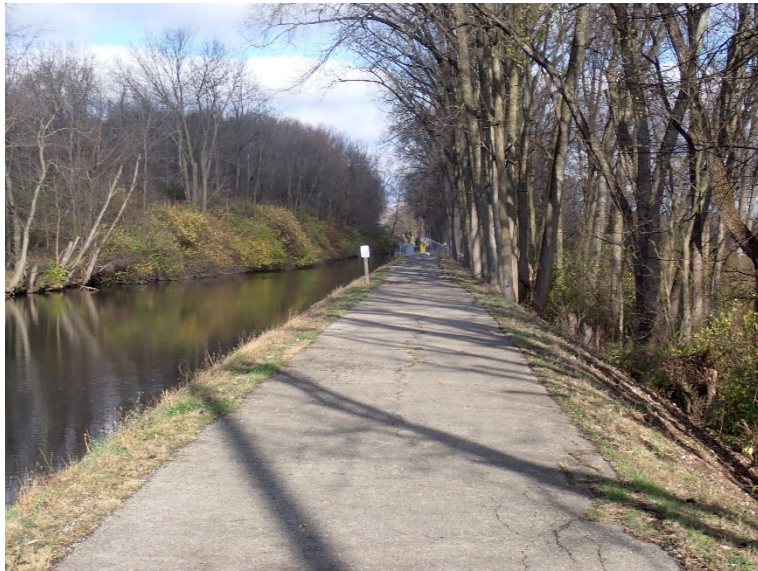
10. Canal path looking north.
Note the dense trees and brush on the canal embankment.

CANAL DUNBANKMENTS MUST BE CLEARED OF TREES AND BRUSH.

1. Remove the trees and brush from the dam and canal embankments. Once cleared, eradicate all rodents and repair the burrows. Seed all disturbed areas to establish a proper grass cover. See the "Trees and Brush" fact sheet for additional information.
2. Remove the pipe penetrations through the dam embankment. Backfill the area with impermeable fill.
3. Investigate the standpipe and opening at the base of the Spillway #1 wall in-line with the standpipe. Include a description in the Operation, Maintenance, and Inspection Manual for the dam.

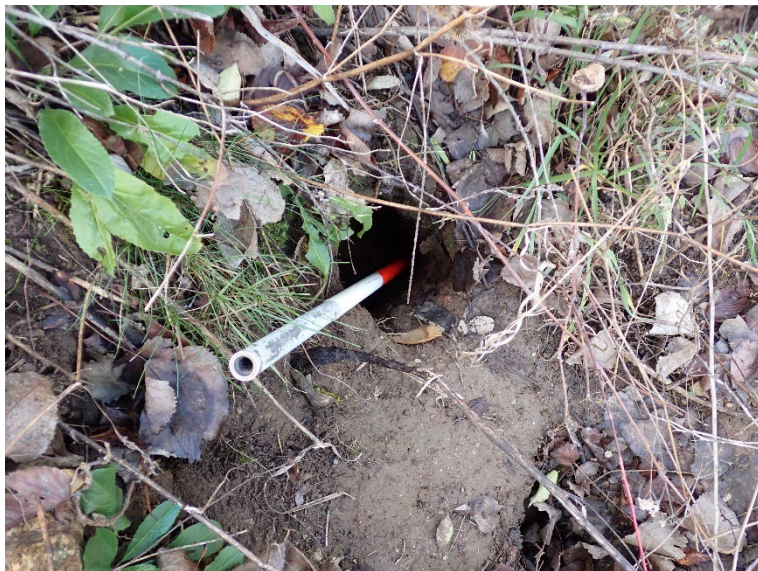
11. Several deep rodent burrows were noted in the canal slope.

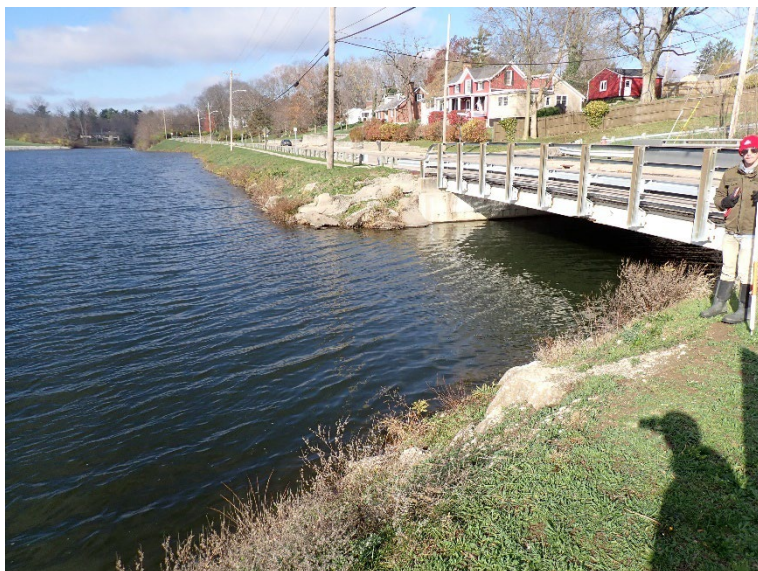
12. Bridge under Echo Lake Drive is main discharge for Echo Lake into the canal.

SPILLWAY #1 ACTS AS PRIMARY SPILLWAY FOR FRANZ POND, ECHO LAKE, AND MOST OF THE CANAL. HOWEVER, THE PRIMARY DISCHARGE FOR ECHO LAKE IS A BRIDGE UNDER ECHO LAKE DRIVE AT THE START OF THE CANAL.

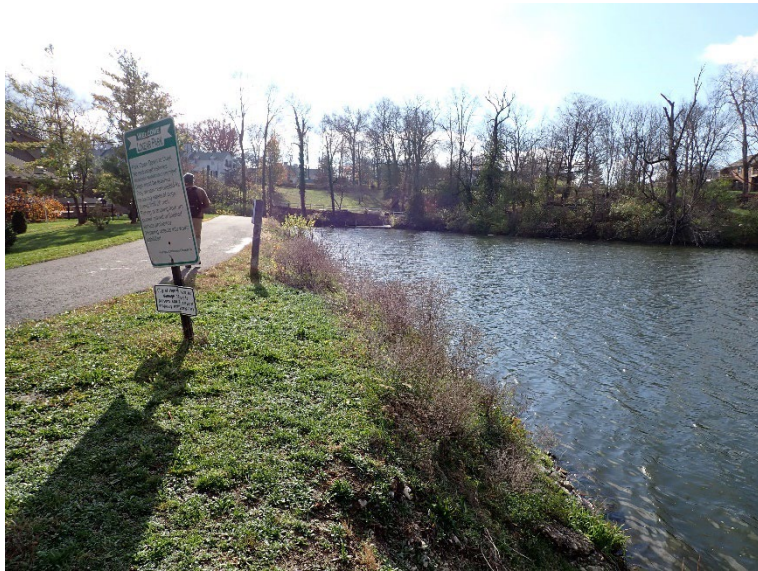
13. View of the upstream slope. Note the brush along the slope.

UPSTREAM SLOPE IS STEEP AND OVERGROWN WITH BRUSH. PREVIOUS INSPECTION NOTED RIPRAP ON A PORTION OF THE SLOPE BUT MUCH OF THE SLOPE WAS OBTSCURED BY BRUSH DURING THIS INSPECTION.

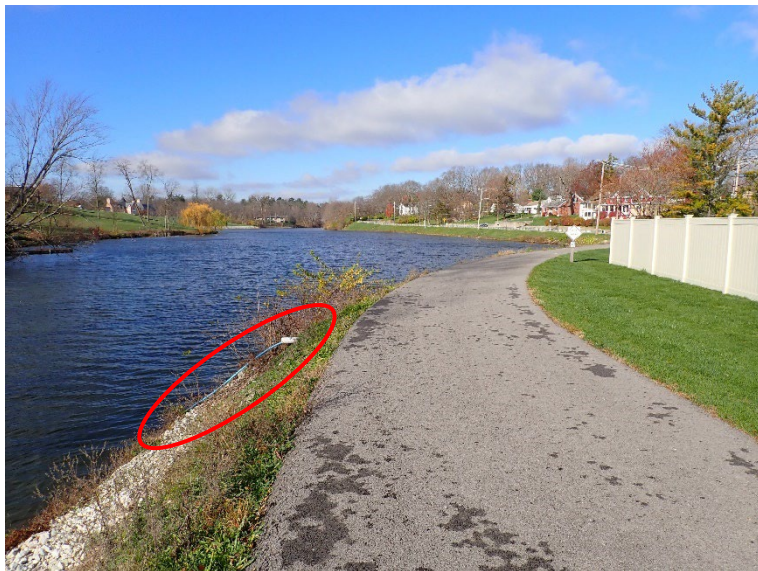
14. View of the dam crest. Note the hoses into a PVC pipe through the upstream slope.

THE PREVIOUS INSPECTION NOTED TWO HOSES THROUGH THE DAM, ENCASED IN PVC PIPE, BUT THEY WERE NOT OBSERVED DURING THIS INSPECTION. ITS UNCLER HOW THEY WERE REMOVED OR IF THEY REMAIN IN PLACE BUT WERE OBTSCURED BY VEGETATION.

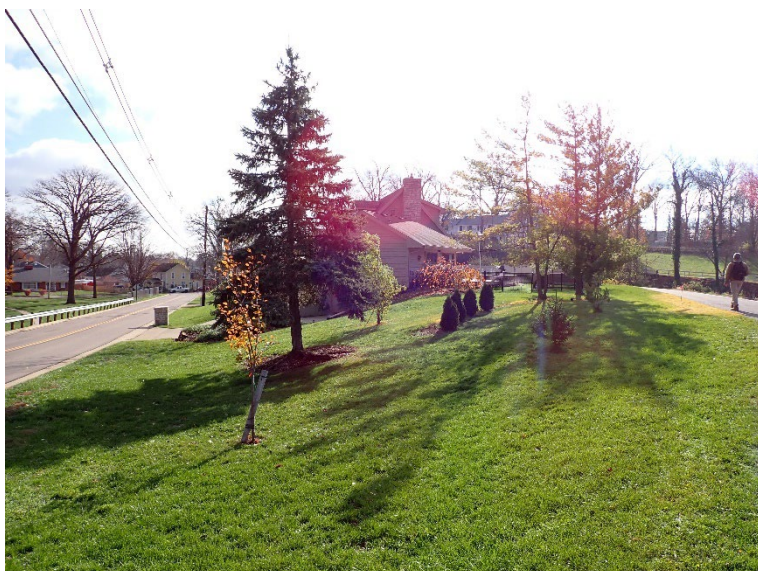
15. There is a house, a swimming pool, and landscaping trees and bushes in the downstream slope.

A HOUSE AND SWIMMING POOL ARE BUILT INTO THE SLOPE.

MULTIPLE MATURE TREES ASSOCIATED WITH LANDSCAPING FOR THE HOUSE NEEDS TO BE REMOVED.
